**Coal Combustion Residuals Landfill Annual Inspection**  
*Nucla Station Ash Disposal Facility*

**Tri-State Generation and Transmission Association, Inc.**

20138863-3-R-0

December 18, 2020

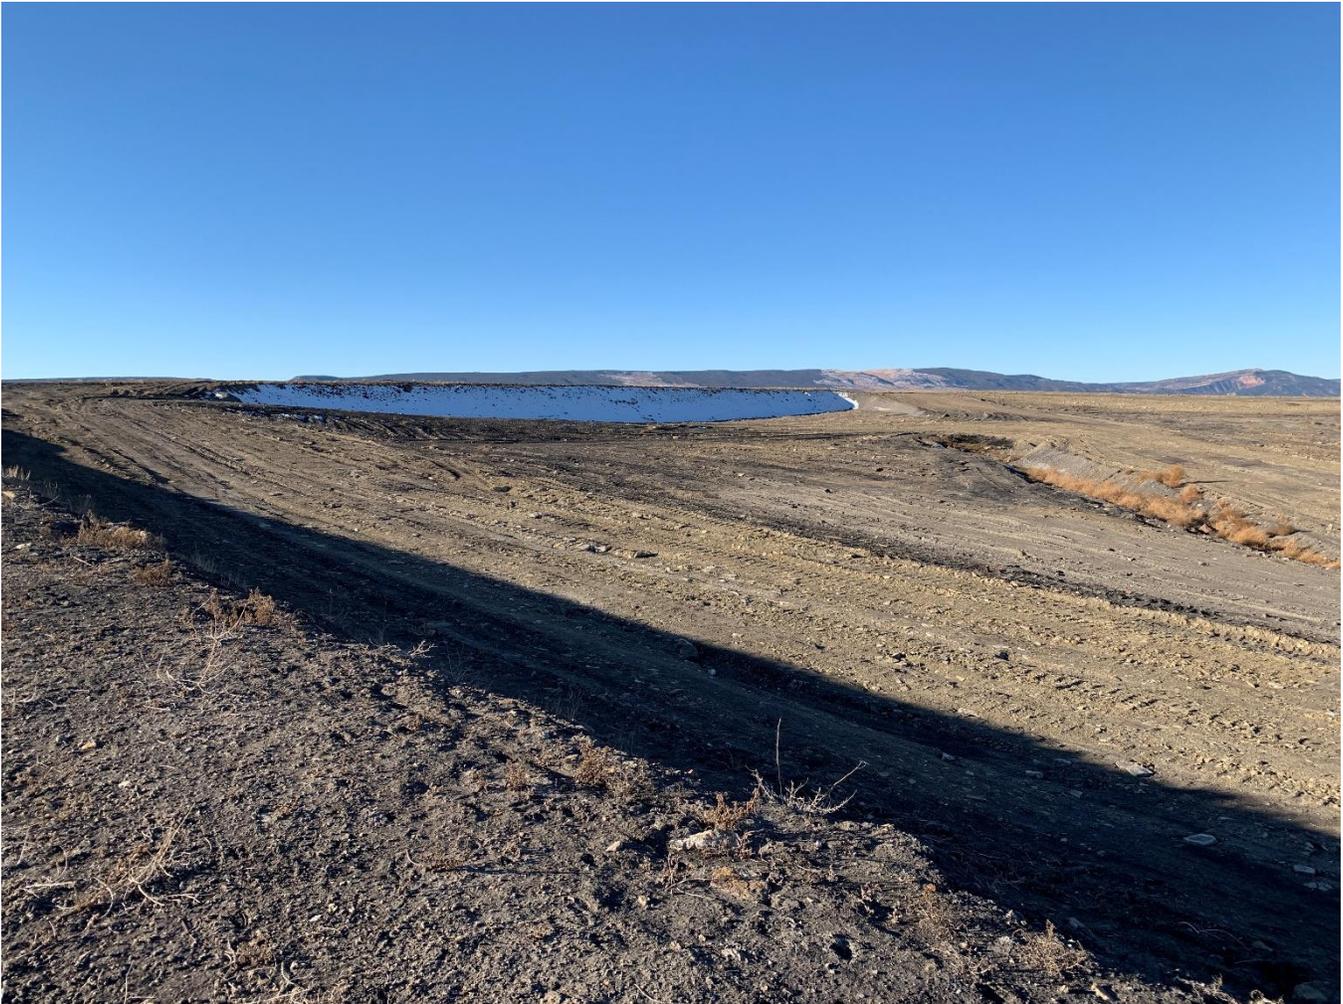
The deposition area was observed to be in good condition (refer to Appendix A for the deposition area location). Signs of ground movement, such as sloughing or sliding, cracking, subsidence, or bulging, were not observed in the deposition area. No deposition was occurring at the time of the visual observation. The deposition area was appropriately graded so that ash contact water would collect and be contained within the deposition area. A berm that was several feet in height was in place around the perimeter of the deposition area to prevent migration of ash contact water out of the deposition area. Fugitive dust was not observed in the deposition area. The typical condition of the deposition area is depicted in Photograph 1.

Photograph 1: Typical Deposition Area Condition

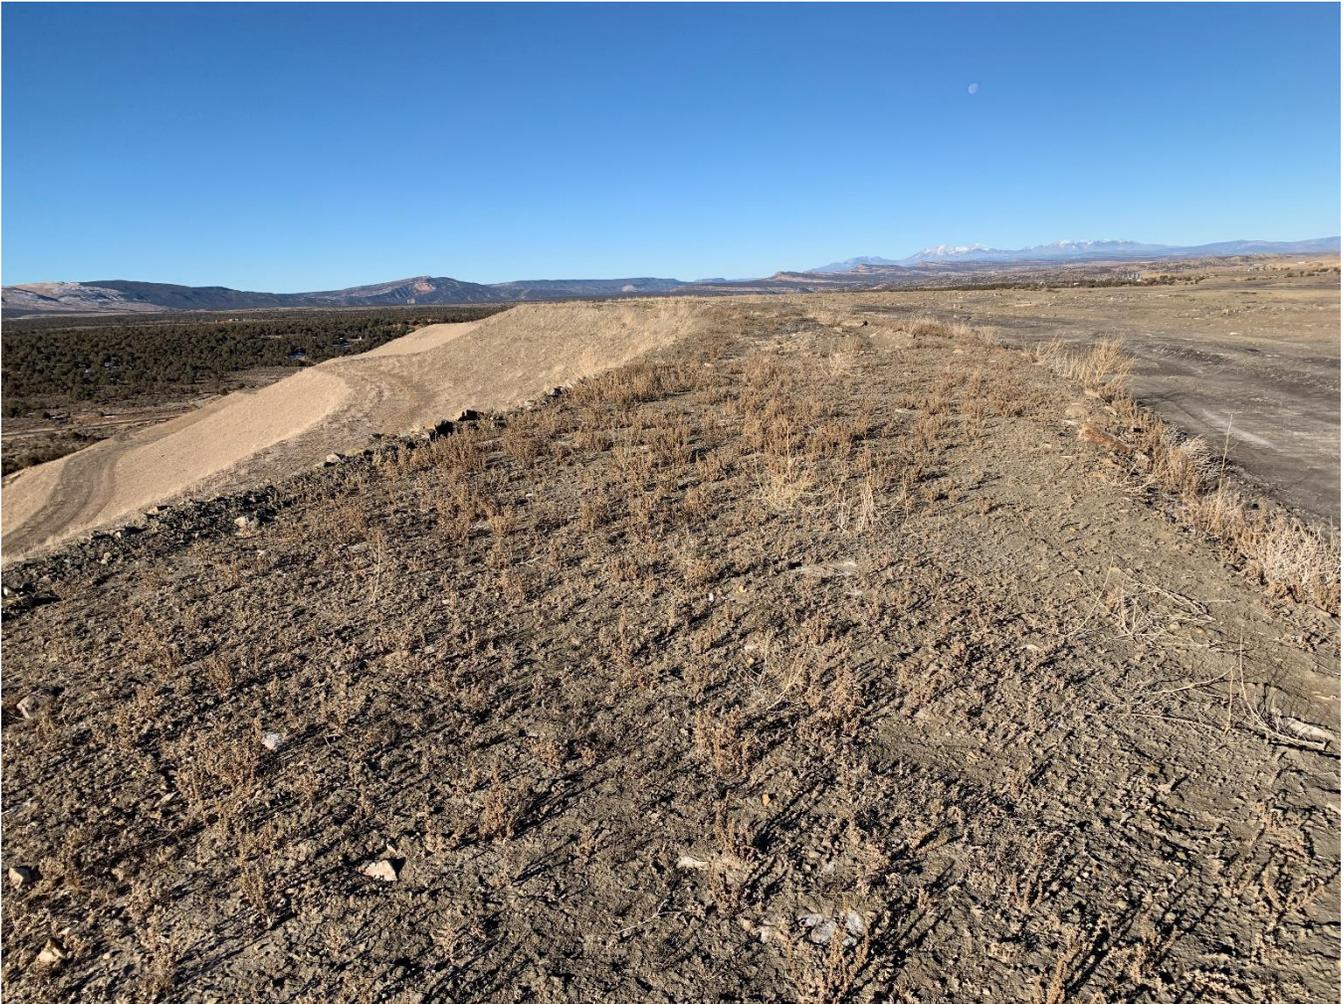
The embankment crest was observed to be in good condition. Cracking that would be indicative of ground movement was not observed along the embankment crest. Low areas that would be indicative of differential settlement were not observed along the embankment crest. The typical condition of the embankment crest is depicted in Photograph 2.

**Photograph 2: Typical Embankment Crest Condition**

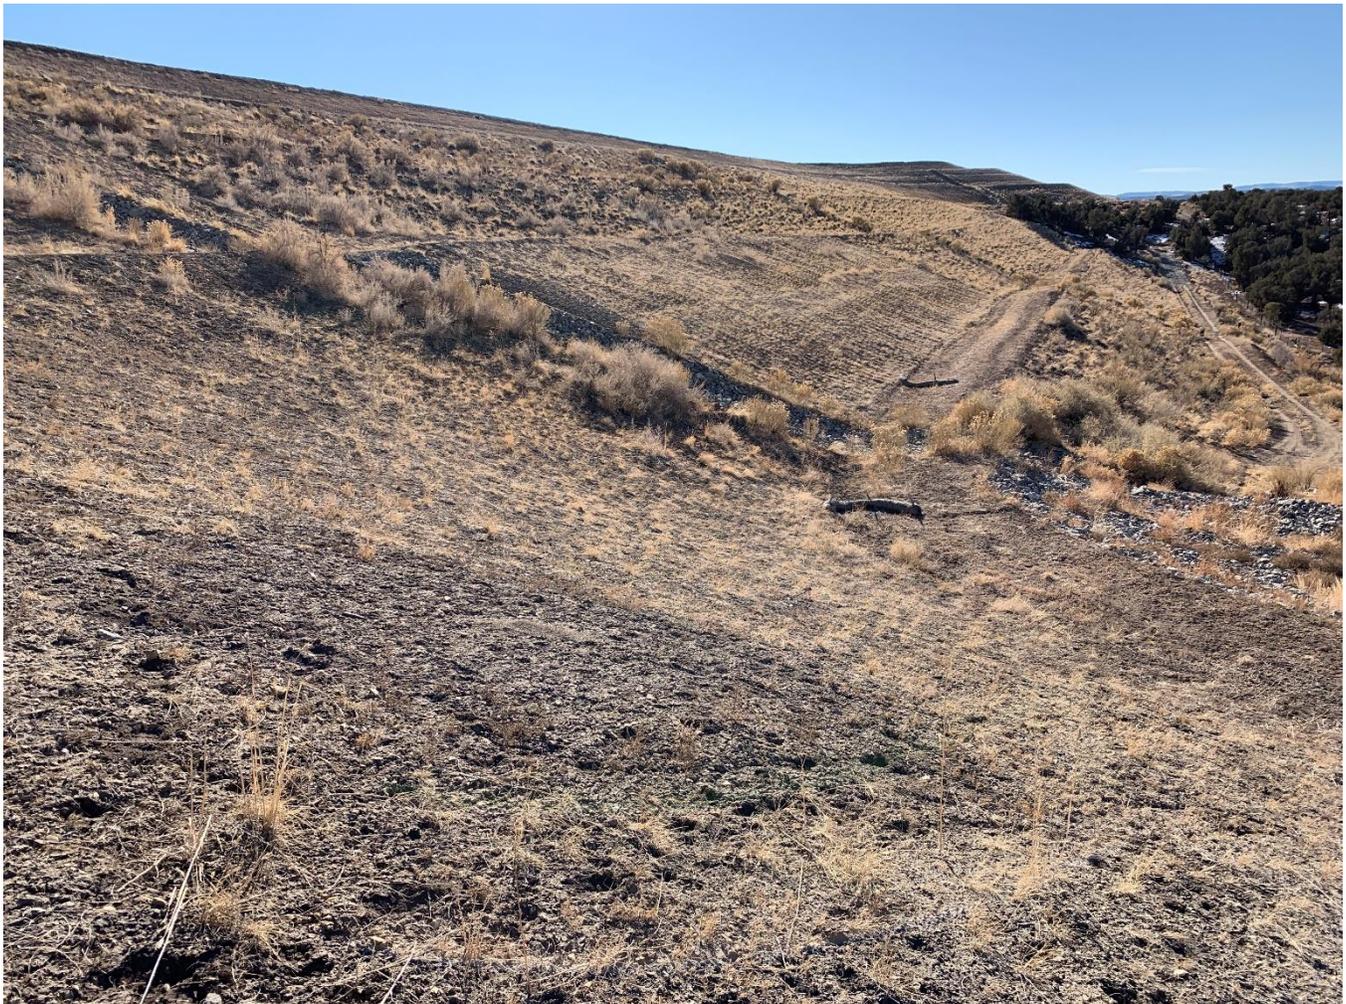
The embankment slopes were observed to be in good condition. Signs of ground movement, such as sloughing or sliding, cracking, subsidence, or bulging, were not observed on the embankment slopes. Evidence of significant or excessive erosion or slope deterioration was not observed on the embankment slopes. It was apparent from visual observation that repair of embankment slopes is being performed as needed, and the weekly inspection forms confirm that repair work was completed on several occasions in 2020 (refer to Appendix A for specific repair locations). Native vegetation has been established on the embankment slopes. The embankment slopes had adequate vegetative coverage at the time of the visual observation, with more mature vegetation on the east, north, and west slopes than on the south slopes. Reestablishment of vegetation in repair locations should be monitored in 2021. Unusually poor or thriving vegetative growth was not observed on the embankment slopes. No trees or woody vegetation were observed on the embankment slopes. Two animal burrows were observed on the embankment slopes, but there was no evidence of recent animal burrowing (refer to Appendix A for animal burrow locations). The typical condition of the embankment slopes is depicted in Photograph 3.

**Photograph 3: Typical Embankment Slope Condition**

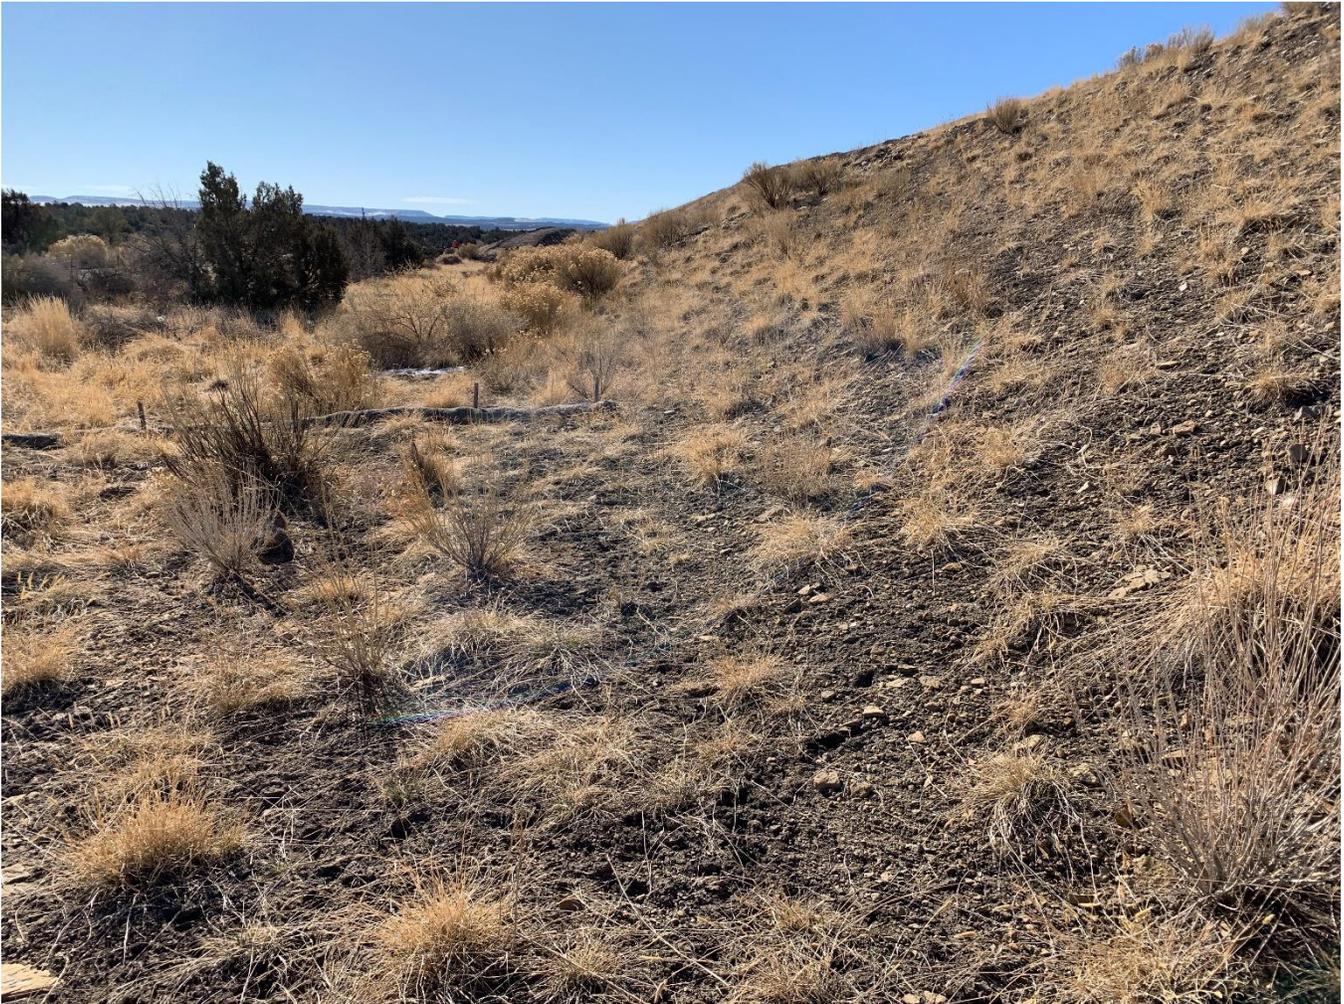
The embankment toe was observed to be in good condition. Signs of seepage, such as springs or boggy areas, were not observed along the embankment toe. The typical condition of the embankment toe is depicted in Photograph 4.

**Photograph 4: Typical Embankment Toe Condition**

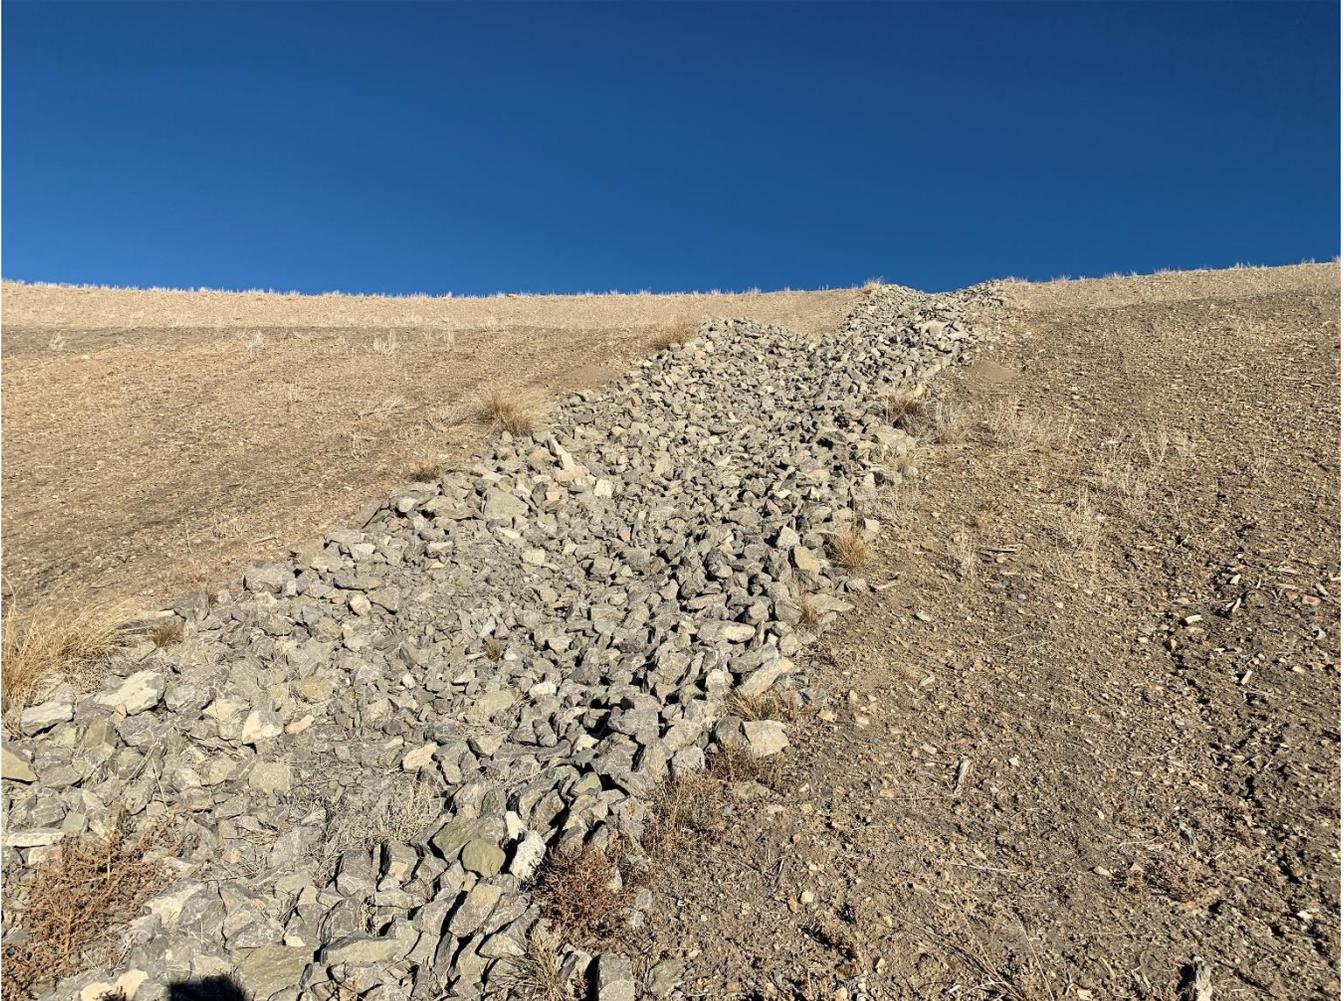
**Photograph 5: Typical Downchute Channel Condition**

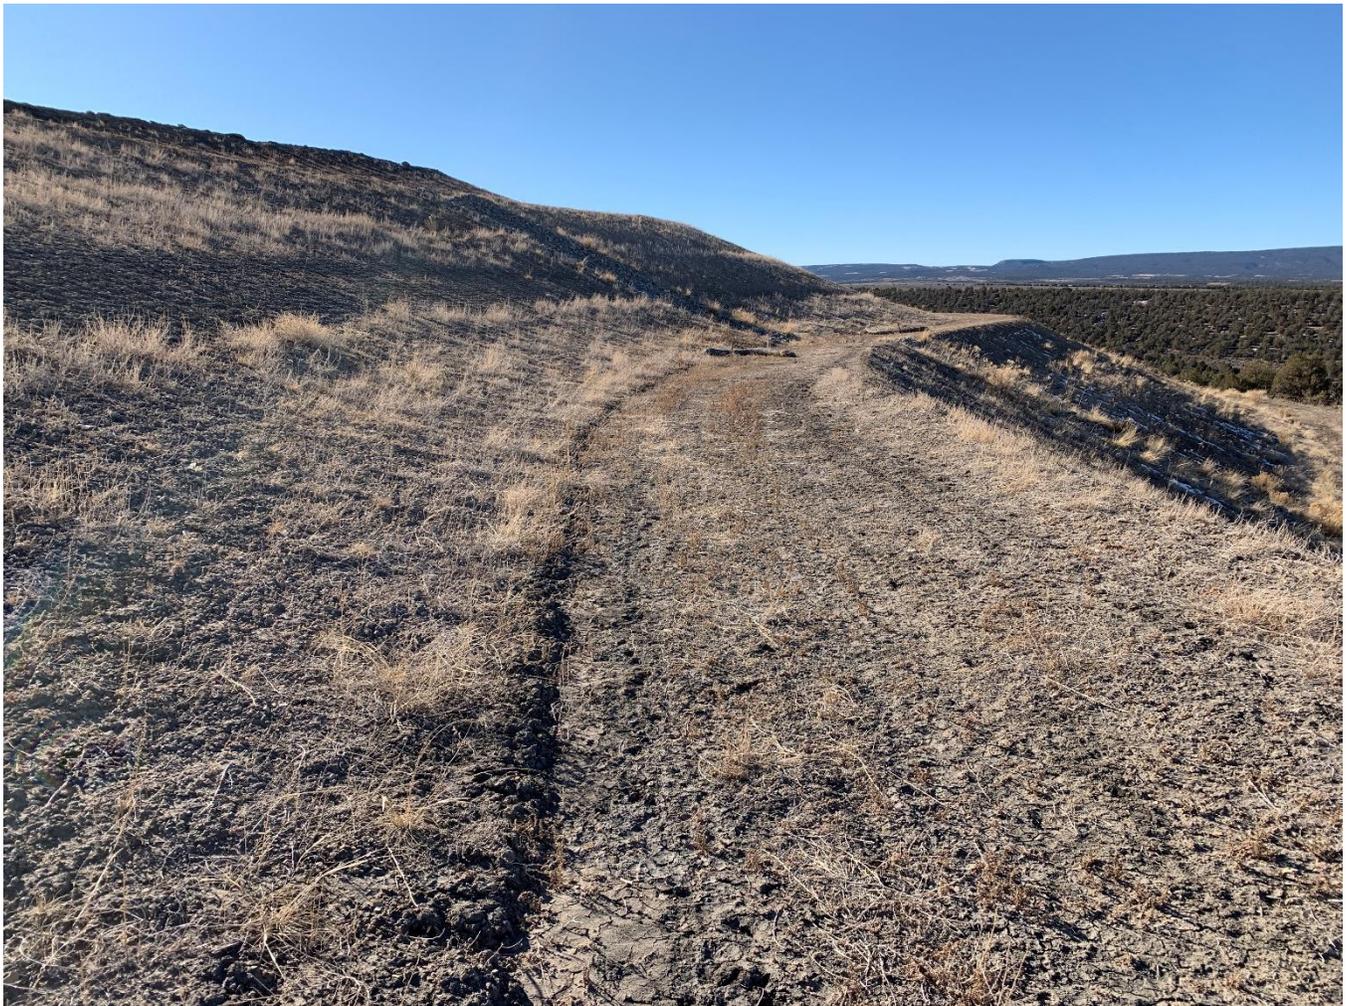
**Photograph 6: Typical Terrace Channel Condition**

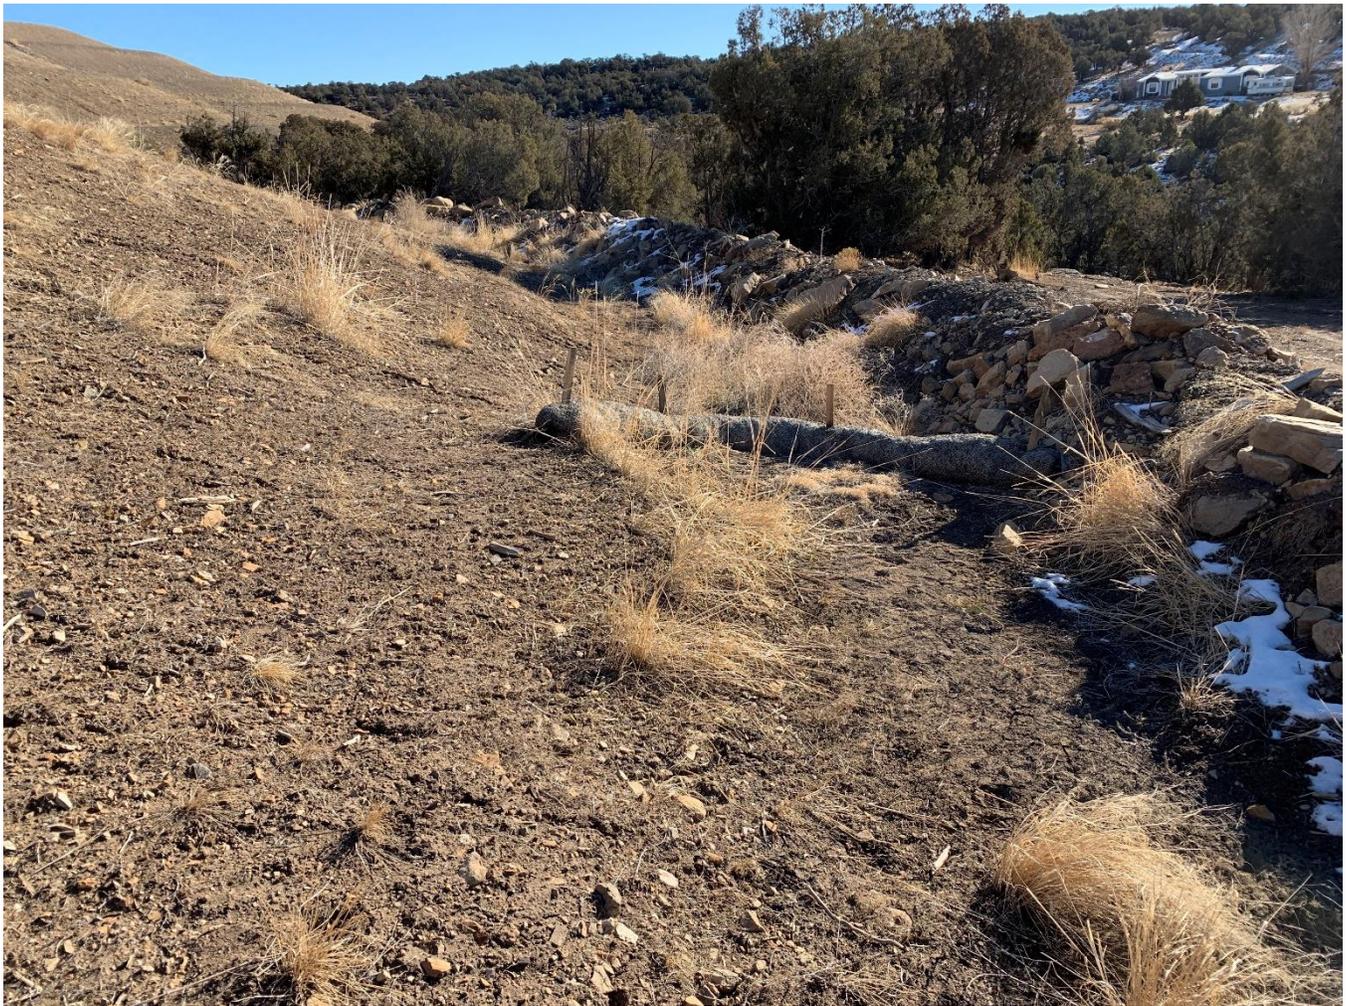
**Photograph 7: Typical Perimeter Channel Condition**
